NATIONAL ADVISORY COMMITTEE FOR AERONAUTICS

TECHNICAL NOTE 3851

FAILURE CHARACTERISTICS OF PRESSURIZED STIFFENED CYLINDERS

By Roger W. Peters and Norris F. Dow

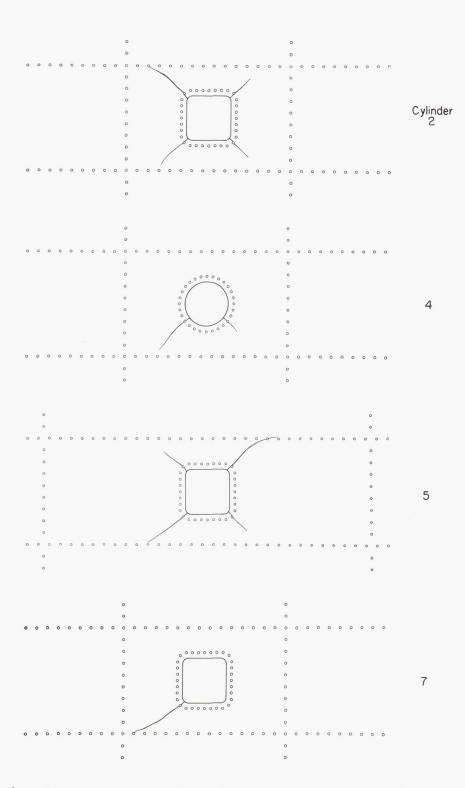
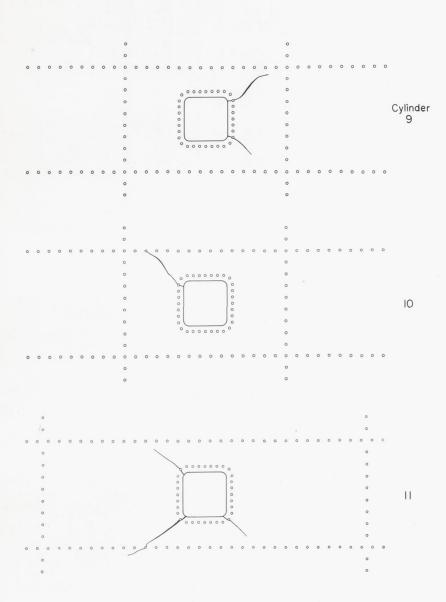
Figure 4.- Final cracks in 30-inch cylinders having gradual failure.

The results of the tests on the 30-inch cylinders are presented in table 1. Two distinct modes of failure occurred: One was characterized by a gradual crack growth (see fig. 4) in which the crack slowly grew to such length that the test was terminated at the limit of the hydraulic pumping capacity; the other is described as an explosive failure in which the crack, after growing a short distance, opened suddenly over one or more bay widths, and failed the ring at one of its notches or tore the skin away from the ring (see fig. 5).

Further observation of the results in table 1 shows that the number of shear-stress cycles between initial cracking and explosive failure was generally small, whereas a somewhat larger number of cycles was required in cases of gradual failures to open the crack sufficiently to necessitate termination of the test. Exceptions to this observation are cylinders 5, 7, and 11 in which only about 50 additional shear-stress cycles were required to open the crack to such an extent that pressure could not be maintained. Because the rate of crack growth in cylinders 5, 7, and 11 in terms of the number of shear-stress cycles was similar to that in cylinder 6 which had an explosive failure, the possibility exists that these cylinders might also have encountered an explosive failure if a somewhat greater pumping capacity had been available to permit continuation of the test. However, close comparison of the cracks shown in figures 4 and 5 reveals that, in all instances, the cracks developed in the cylinders having a gradual failure (fig. 4) were much longer than the cracks developed in the explosive cylinders before explosive failure (fig. 5).

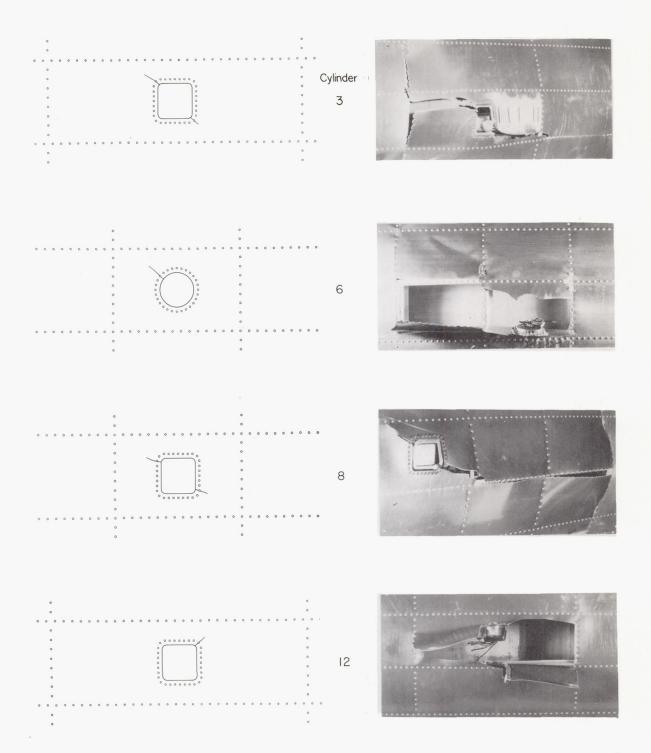
L-95811

From the results in table 1 it may be observed that the hoop stress level was not the sole cause of the difference between the modes of failure. For example, cylinders 4 and 9 experienced a gradual crack growth at a higher hoop stress level (30 ksi) than that for cylinders 3 and 12 (20 and 22.5 ksi, respectively) which had explosive failures.

Figure 5.- Cracks before and after explosive failure in 30-inch cylinders.

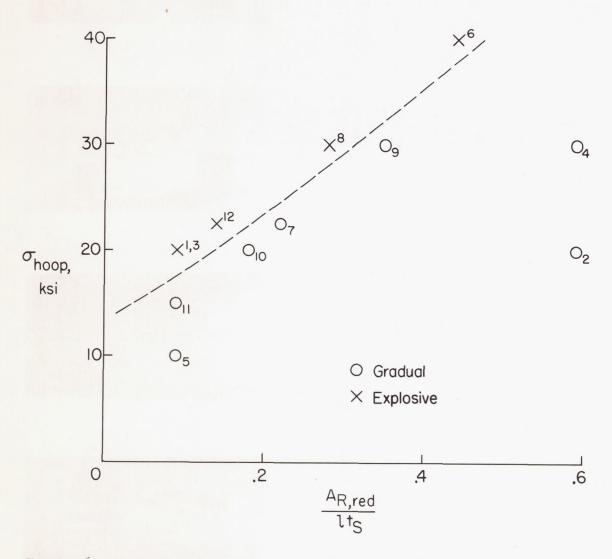
These data on the tests of the 30-inch cylinders are also presented in figure 6 in which the hoop tensile stress σ_{hoop} induced by the

internal pressure is plotted against the reinforcement ratio \bullet the ratio of the cross-sectional area in the rings $A_{R,red}$ to the associated skin area lt_S (ref. 4). The x-points represent those cylinders which failed explosively and the circles represent cylinders which experienced a gradual crack growth. The numbers adjacent to the test points refer to the cylinders listed in table 1. The test points tend to establish a pattern which permits drawing a boundary, such as that shown by the dashed curve, between the regions of explosive and nonexplosive failures. The boundary shown is considered valid only for cylinders of 2024 aluminum alloy having stringers and notched rings riveted directly to the skin.

Figure 6.- Regions of explosive and gradual crack growth as determined by tests of 30-inch stiffened cylinders of 2024-T3 aluminum alloy.

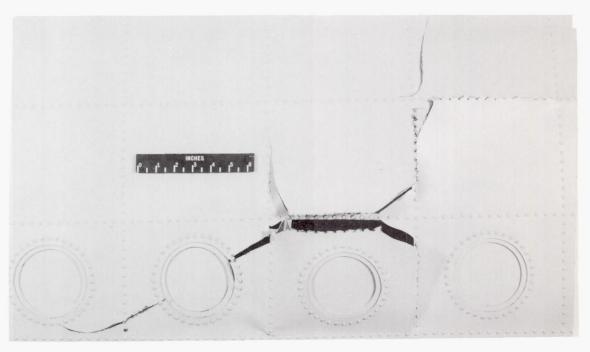
L**-**95812

The results of the tests on the 48-inch cylinders to compare the failure characteristics of 2024 and 7075 aluminum alloys are presented in table 2. As noted in the previous series of tests, two modes of failure occurred. Cylinder 15, constructed of 7075 aluminum alloy, experienced an explosive failure; whereas cylinders 13 and 17, constructed of equal thicknesses of 2024 aluminum alloy and tested at the same nominal hoop tensile stress (30 ksi), failed in a gradual manner. A similar comparison exists between cylinder 19 (7075 aluminum alloy) and cylinder 18 (2024 aluminum alloy) which were tested at $\sigma_{\rm hoop}$ = 25 ksi. Cylinders 16 and 14 (7075 and 2024 aluminum alloys, respectively), which were tested at $\sigma_{\rm hoop}$ = 20 ksi, both failed in a gradual manner.

The explosive failures of cylinders 15 and 19, however, differed from the explosive failures previously described in that the explosions occurred without any visible signs of crack initiation prior to the failure. A comparison of the failures of cylinders constructed of these aluminum alloys is illustrated in figure 7.

(a) Cylinder 13; σ_{hoop} = 30 ksi; t_{S} = 0.015 inch 2024 aluminum alloy.

(b) Cylinder 15; σ_{hoop} = 30 ksi; t_S = 0.016 inch 7075 aluminum alloy. Figure 7.- Comparison of failures of 2024 and 7075 aluminum-alloy cylinders.

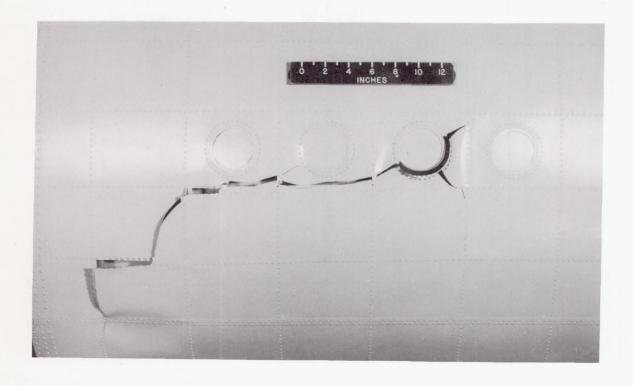
L-95813

(c) Cylinder 18; σ_{hoop} = 25 ksi; t_{S} = 0.025 inch 2024 aluminum alloy.

(d) Cylinder 19; σ_{hoop} = 25 ksi; t_{S} = 0.025 inch 7075 aluminum alloy. Figure 7.- Concluded.

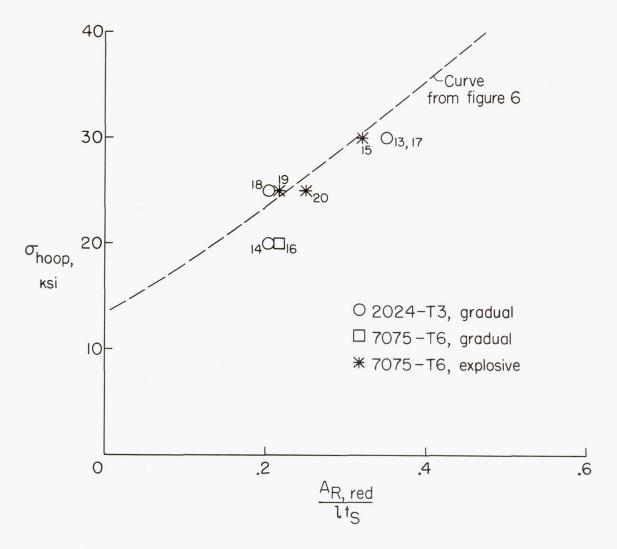
The data from the tests of all the 48-inch cylinders are presented in figure 8 in which the nominal hoop tensile stress is plotted against the reinforcement ratio $\frac{A_{R,red}}{lt_{G}}$. The cylinders of 7075 aluminum alloy

which experienced explosive failure are represented by asterisks, and the cylinders of 2024 and 7075 aluminum alloy which experienced gradual failure are represented by the circles and squares, respectively. The boundary established in figure 6 by the tests of the 30-inch cylinders is drawn on this figure for comparison. The number of explosive-failure points for the cylinders of 7075 alloy falling below this curve indicate that the boundary established from tests of 2024 cylinders may be somewhat high for cylinders constructed of the more explosive-prone 7075 alloy.

Figure 8.- Explosive and gradual crack growth as determined by tests of 48-inch cylinders of 2024-T3 and 7075-T6 aluminum alloy.
